# BELZONA PROVIDED A BETTER GRIP ON A CAISSON CLAMP PIPELINE SUPPORT

ID: 9777

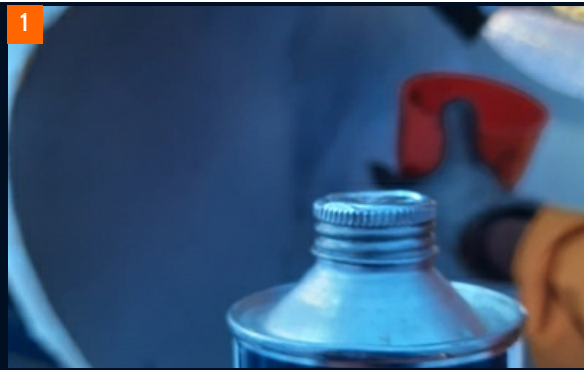
1. Belzona 2921 Surface Conditioner Application
2. Belzona 2111 (D & A Hi-Build Elastomer) Bonding material application
3. Clamping using a dummy pipe to compress the Neoprene Rubber sheet
4. Completed Bonding Application

Belzona 2921 (Elastomer GP Conditioner) is a surface conditioner which is the elastomeric primer required for better adhesion of Belzona elastomers onto any rigid and flexible substrates.
