# TIPPING HALL BAYS IN AN ENERGY FROM WASTE PLANT SURVIVE CONSTANT ABRASION WITH BELZONA SOLUTION

ID: 9780

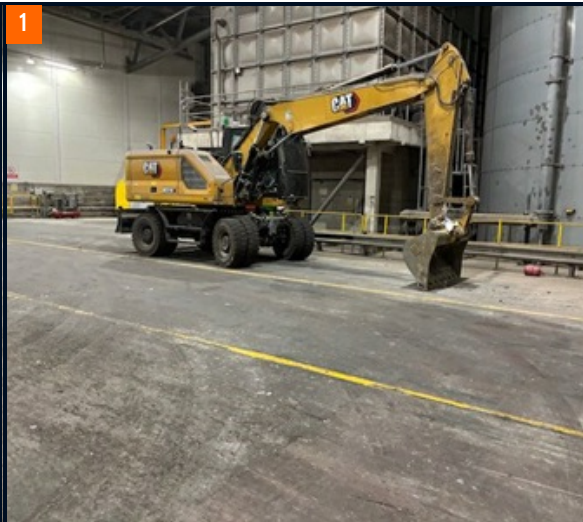
1. Heavy Plant Used to Shovel Non-Recyclable Waste
2. Bay Lanes Being Recessed Into Concrete
3. Parking Bay Numbers also Recessed Into Concrete
4. Completed Lorry Parking Bays and Numbers after application of Belzona 5231 Yellow
