# BELZONA 4111 PROVIDES A QUICK FIX AND REPAIR ON DIPS IN A STEEL TANK ROOF

ID: 9791

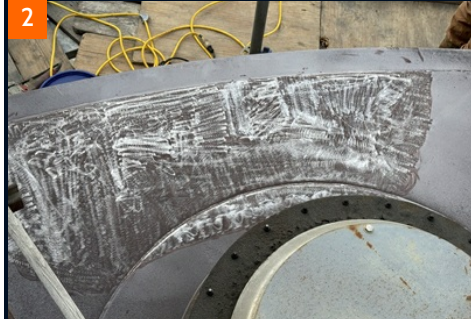
This asphalt tank roof was experiencing a few low areas where water would collect for long periods of time after rainfall. Previous installation of the roof structure renovation was struggling and created the concave areas. The pooled water threatened damage to the areas in question.

1. You can see the pooled water in the dip areas on the tank roof needing to be addressed.
2. A diamond wheel grinder was used to achieve the appropriate profile on the low areas on the steel. The area was extended beyond the low points to be able to feather the product out and recreate a slope.
3. Belzona 4911 Conditioner is seen here be applied on top of the prepared steel.
4. Belzona 4111 was trialed over the prepared areas and is set for future protection.
