# BELZONA GIVES BETTER PROTECTION ON EXTERNAL LINING OF WATER WELL PUMP

ID: 9794

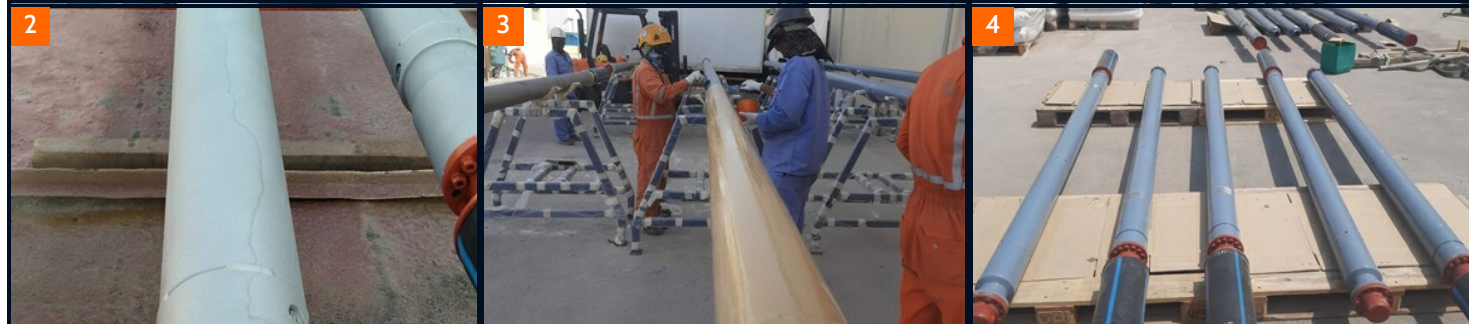
## PHOTOS

The newly fabricated water well pumps has been coated initially with a red epoxy primer, it has been done on the previous pumps used by Client, top coated with a undisclosed epoxy type of coating. After a month in service, the coating was promptly deteriorated in which the metal surface was exposed in a harsh environment during the process.

1. The newly fabricated well pump coated with red epoxy primer.
2. Using vapour blasting, the epoxy primer is being removed and metal surface was exposed.
3. Belzona 5821 coating application was done in 3 coat system to achieve the required thickness of 400-500 microns.
4. Belzona 5821 application was completed with a final coat in slate grey.

1. The water well pump was initially blasted in accordance with Belzona guidelines of Surface Preparation procedure written in the IFU (Instructions for Use) which is to provide a required Cleanliness Standard of SA 2.5 with a minimum of 75 microns surface profile.
2. Belzona 5821 coating application was done in accordance with System Leaflet CEP-4 provided with an approved method statement. The coating was applied by manual application by stiff bristled brush in a thin layer per coat with maximum thickness of 150 microns only to maintain the smoothness of the coating being applied preventing it from sags occurrence.
3. Three-coat system was done to achieve the required thickness of minimum 400 microns but not more than 500 microns.
