# COLD BONDING USING BELZONA 7311 ON A YACHT HULL

ID: 9834

## PROBLEM

The requirement for a long term structurally sound solution to cold bond a Hawse pipe structure and anchor pocket to a yacht hull.

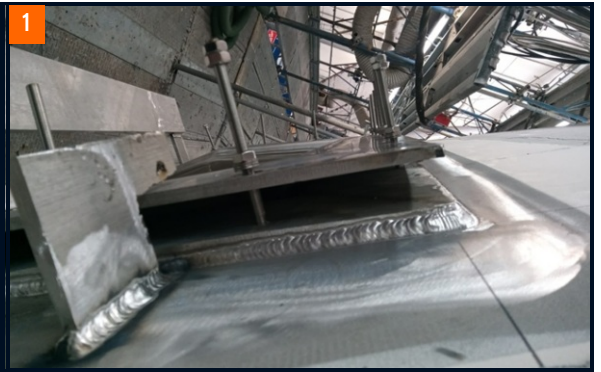
1. Structure that required the bonding solution.
2. Surface preparation complete.
3. Belzona 7311 applied.
4. Finished application of Belzona 7311.

This Customer was looking for a cold bonding solution to bond a Hawse pipe structure and anchor pocket to their yacht hull. The anchor pocket, which was made of stainless steel, is typically secured either mechanically through heavy bolting or welding, often with the use of bimetallic coupling plates to ensure compatibility between dissimilar materials. This process is technically complex, as welding dissimilar metals can often lead to significant corrosion issues, while mechanical anchoring risks water ingress can cause aesthetic defects such as blistering or water pockets beneath the yacht's hull coating.
