# CRACKED COKE GAS PIPE

ID: 9848

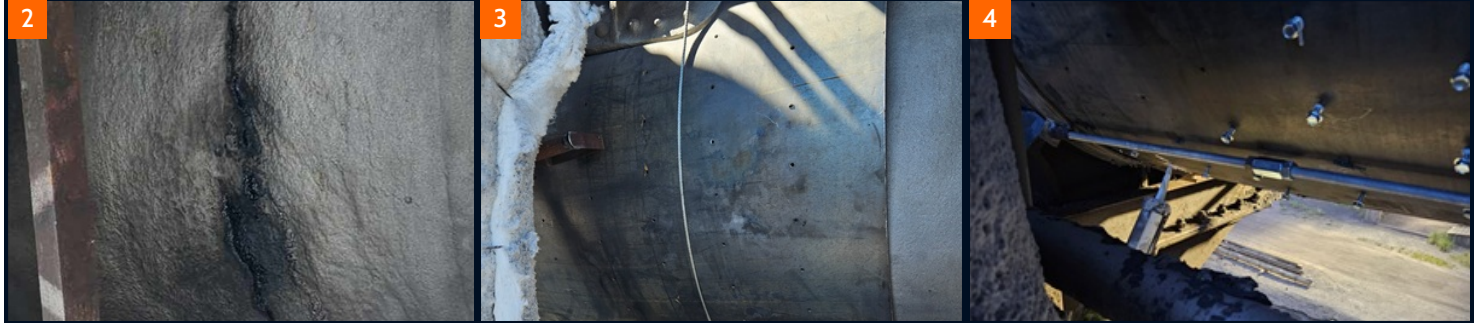
The customer had problems cracking and leaking. This had to be both sealed and reinforced. Hot work was not possible as the pipe transports combustible gases. This process could not be shut down, so we had to find a solution together with the customer to be able to perform this during operation.

1. Here we have the area with the crack, tar has leaked out and at the moment the pressure is reduced so no smoke is leaking out
2. Here the crack is clearly visible after blasting. We have drilled holes at the ends of the crack to minimise the risk of the crack moving on.
3. Installation of the reinforcement plate and clamps and sealing of the edges with Belzona 1511
4. Injecting with Belzona 1391T to fill the space between the sheet and the pipe. We started at the bottom and worked our way up. This way we both bond and seal the whole system.

Our solution was to perform this using a mechanical clamp together with grouting the space between the pipe and clamp with Belzona 1391T. This sealed and fixed the area to ensure it was tight and able to withstand future movement in the area.

Prior to this project, a site visit was made to identify the damage, and to measure what the reinforcement sweep would look like. Once on site, we blasted the area to see the damage in its entirety and drilled holes at the ends of the crack to prevent it from travelling further. Patched the damage with Belzona 1212. Welded off the area again and the sheet metal sweep. Fitted the sheet metal sweep. Patched the edges with Belzona 1511 to prevent leakage during injection with Belzona 1391T.
