# LIGHTWEIGHT BELZONA MAKES ROPE ACCESS A COMPETITIVE OPTION

ID: 9858

Buildings & Structures

Leicester

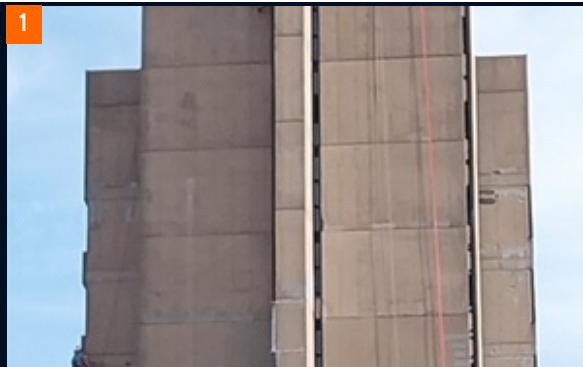
1. General view of the West face of the building, showing IRATA L3 Rope access engineers carrying out repair works with Belzona 4911 and Belzona 4141
2. IRATA L3 Engineers able to carry out more repairs with less returns to base, thanks to the incredibly lightweight properties of Belzona 4141
3. Repairs to vertical sections of the walls
4. Repairs to vertical wall, combined with overhead repairs.

Belzona's lightweight Magmabuild 4141 really paid off for the Rope access company, allowing them far more working time on the ropes, in situ, than any other competitor of concrete repair products could match. This decreased the number of ascents back to base to "refill" and carry on. The overall cost saving, in time, meant that Rope Access was far more competitive than scaffold or mechanical platforms, allowing one of our preferred contractors the ability to win the project and pass on the savings to the end client
