# HEAVY FORKLIFT TRAFFIC CONCRETE FLOOR AREA REPAIRED AND PROTECTED

ID: 9866

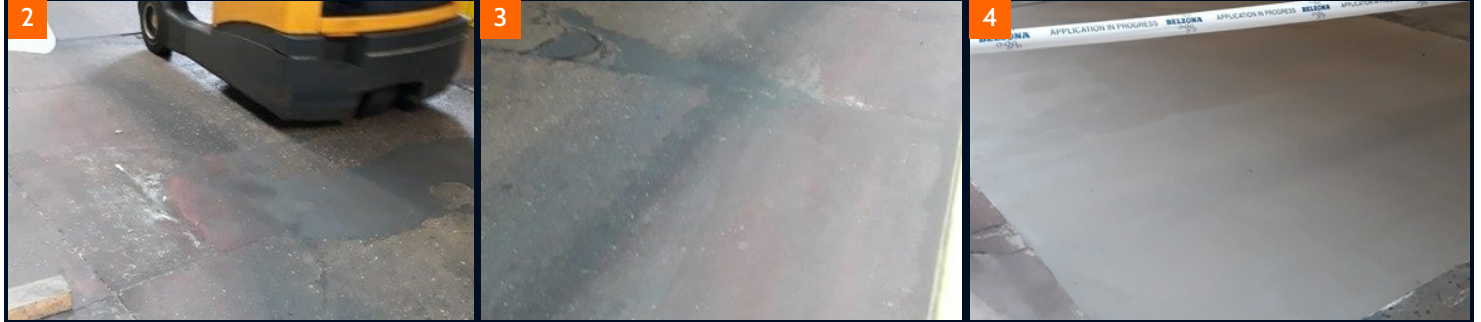
The main entrance to a large warehouse was continually pounded by constant forklift traffic entering the building. The traffic wore away the surface, eventually leading to the surface starting to break up. The area had been "repaired" using other methods a number of times, none of which created a durable solution

1. Main entrance for all forklift traffic into 4.6 hectare warehouse
2. Constant heavy traffic using the entrance
3. Damage caused by constant heavy solid wheel handling machinery
4. Area completely screeded at an average of 6mm using Belzona 4911 TX Conditioner and Belzona 4131 MagmaScreed

All loose and friable materials were scraped out and the surface was vacuumed  
A thin application of mixed Belzona 4911 TX conditioner was applied by short bristled brush  
The Belzona 4131 MagmaQuartz was mixed in a Daines, or Forced Action mixer and applied by gloved hand  
Screeding bars and finishing trowels were used to create a perfect new surface, some 3 times the compressive strength of most floor grade concretes. Also this is now impervious to water and chemicals
