# EXTERNAL CORROSION TO PIPE REQUIRED A LONG TERM SOLUTION

ID: 9869

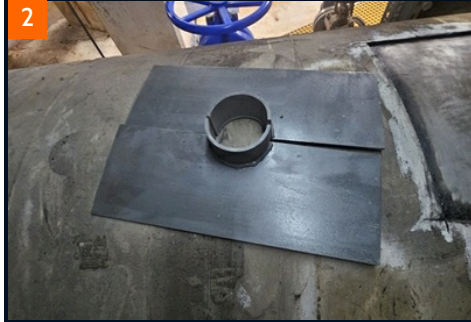
The high lift pumping station (HLPS) Delivery Water Main was situated within a culvert. Over time, a section of this main has thinned due to external corrosion. Originally, the wall thickness was believed to be 12mm, but the area at nozzle had reduced to approximately 7mm

1. Pipe at nozzle was suffering from external corrosion
2. Cold applied plate bonding was selected as the long-term protection solution
3. The pre-fabricated plate was fitted around the nozzle and loaded with Belzona 1111
4. Belzona 1111 was filleted, presenting a smooth finish and completing the long term protection solution
