# EXPANSION JOINT IMPROVED TO SAVE DAMAGE TO FORK LIFTS

ID: 9871

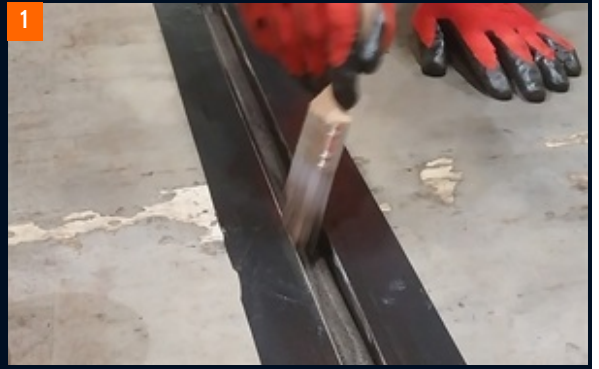
1. Joint taped and the application of Belzona 2911 Conditioner
2. Pouring in the Belzona 2211 Hi Build Elastomer
3. Expansion joint filled and tape removed
4. Trial Joint almost 12 months later

Apply Belzona 2911 conditioner as per spec

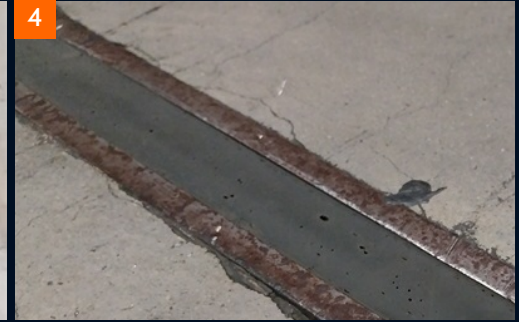
Fork Lift repair and maintenance costs are expected to reduce drastically, thanks to the Belzona application. Almost 1 year on, the joint has held perfectly well. The company are now considering carrying out the same repair to a further 4km+
