# BOILER HOUSE EXTERNAL AREAS

ID: 9873

## PROBLEM

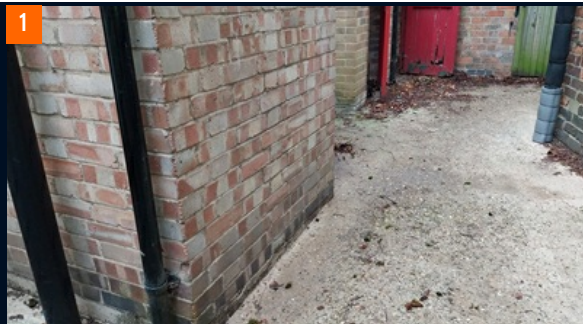
This is an unusual area, in that it appears to be a floor area, but is also a roof area to an underground boiler house. The client was having issues with water ingress, mainly from the joints above the boiler house. A scope was suggested to flaunch the interfaces between the concrete floor and brickwork areas, followed by 2 coats of Winter Grade Belzona 3131

1. Showing areas of possible leakage through to the underground boiler house
2. Flaunch applied at 35mm 45 degrees slope to ensure there is no square edge termination point to the Belzona 3131
3. All flaunching completes
4. Completed with 2 x coats Belzona 3131
