# EXPANSION JOINT REPAIRED USING BELZONA

ID: 9880

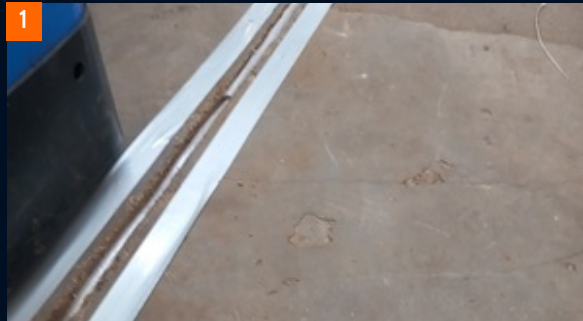
1. Area demarcated, prepared and cleaned
2. Foam Backer rod installed and Belzona 2911 (Elastomer QD Conditioner) applied
3. Expansion joint complete and tape removed
4. Problem solved with the Belzona 2211 (MP Hi-Build Elastomer) ensuring an even run for the hand pallet trucks

Remove all loose and friable material from the target area

Vacuum the joint to remove dust and debris

Tape the sides of the joint to help deliver a clean application line
