# BELZONA 5815 NON-SKID PARKING AREA

ID: 9890

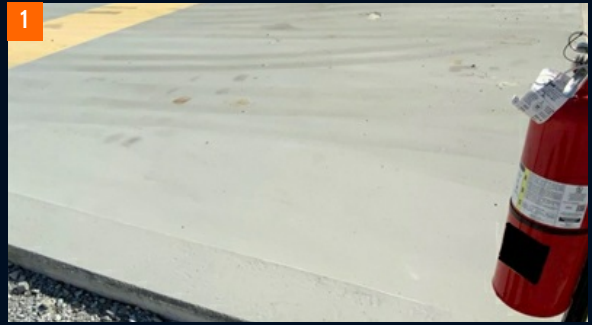
This area had only been coated less than a year. The coating had started to peel away from the concrete surface in sheets causing this area to be non-compliant for chemical tanker storage.

1. Before picture of the current coating that has delaminated in many areas.
2. Removal process of the current coating. Look how this coating just peeled away in sheet. This was caused from poor surface preparation.
3. Close up picture of Belzona 5815 with added aggregate for a non-skid finish.
4. Final result of using Belzona 5815 with aggregate in this truck parking area.
