# BELZONA 4311 PROTECTS CHEMICAL STORAGE ROOM

ID: 9893

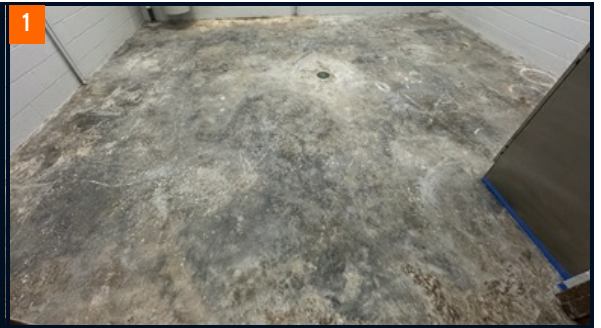
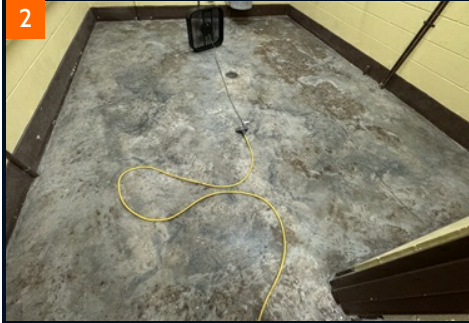
Our customer was looking for a coating to protect a concrete floor in a storage area. Sulfuric acid was going to be placed in this storage area to be staged for use and they were looking for a way to protect the floor in the event of spills.

Our customer was looking for a cost efficient floor coating to protect chemical storage floors in the event of spills. These areas existed as closets before so the concrete was in good shape, just needed to be prepared for the coating.

1. Chemical Storage Area 1 - Prior to Grinding/ Standard concrete floor
2. Chemical Storage Area 2 - Prior to Grinding / Standard Concrete Floor
3. Completed (1) Coat of Belzona 5811 and (1) coat of Belzona 4311
4. Completed (1) Coat of Belzona 5811 and (1) coat of Belzona 4311

We used a diamond wheel grinder to bring the concrete to bare and provide a roughened profile. We then applied 1 coat of Belzona 5811 to the floor and following with (1) heavy coat of Belzona 4311 on top. Both areas completed in 2 days.
