# BELZONA 1111 & 1321 REBUILD UNDERWATER GENERATOR HOUSING

ID: 9898

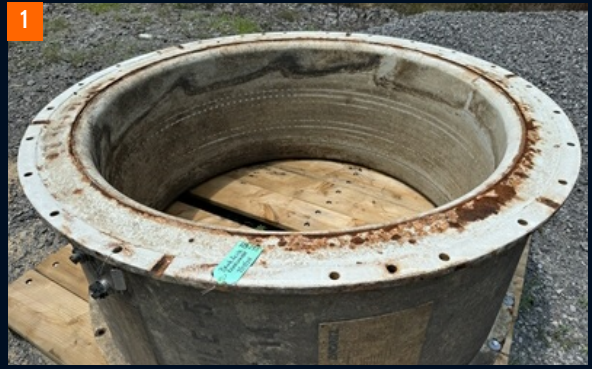
Our client is a motor manufacturer & repair shop that is industry wide. They received a fiberglass lined steel generator housing that is used submerged to process water through a hydro dam. The housing (1 of several) had been in service 25+ years and had started to see a leak into the motor area from the fiberglass internal ring. The design was no longer manufactured and could not be sourced, Belzona offered an option rebuild it.

1. Generator Housing - Before
2. After removing the original fiberglass liner, it was re-seated into the housing. To machine to fit the fan blades that place within, Belzona 1111 was used to build up the housing to spec, and then was machined to fit.
3. First coat of Belzona 1321 applied on top of the machined 1111.
4. Final Coat of Belzona 1321 applied.
