# BELZONA REBUILDS & PROTECTS CHILLER HEAD COVER

ID: 9914

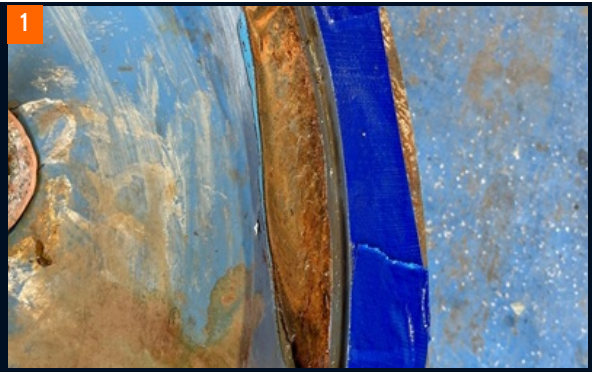
Client was completing the annual maintenance on their chillers and noticed damage on the end covers. The asset was previously lined by a competitor to Belzona, and it was failing around the edge. A chunk of the end cover came off which caused concerns. The previous coating was delaminating, metal loss was occurring and made it unsafe to put back into service.

1. Defect area
2. Defect area #2
3. Rebuilt edge
4. Final result with two coat system of Belzona 1321

1. Power tool prep to remove loose adhered coating and roughen up metal (SSPC-SP11)
2. Substrate was wiped clean with Belzona 9111 and let dry.
3. Belzona 1121 was applied to rebuild lost metal.
4. Belzona 1321 applied in a two coat system
