# GROUNDWATER LEAKS INTO JET FUEL PIPE REPAIR

ID: 9916

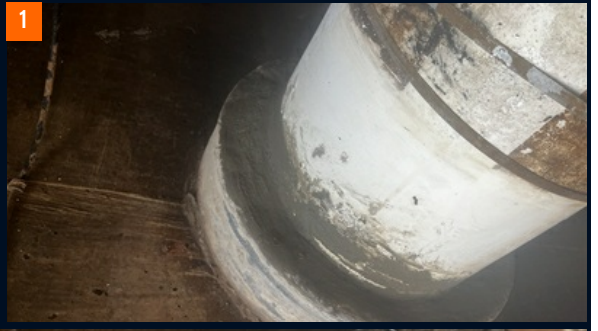
Groundwater was entering around a jet fuel pipe penetration, causing the vault to fill up with water.

1. Leaking pipe penetration
2. Building up around pipe from concrete with Belzona 4141
3. The finished product using Belzona 5815 with 9311 reinforcement

Cleaned up area with 5,000 psi pressure washer wiped down with MEK. Applied Belzona 4911 conditioner, applied Belzona 4141 to penetrating areas to build up to a transition. Applied Belzona 5815 with Belzona 9311 reinforcing sheet twice. Went back the next day and no leaks.
