# BELZONA 5811 PROTECTS CHEMICAL STORAGE AREA

ID: 9937

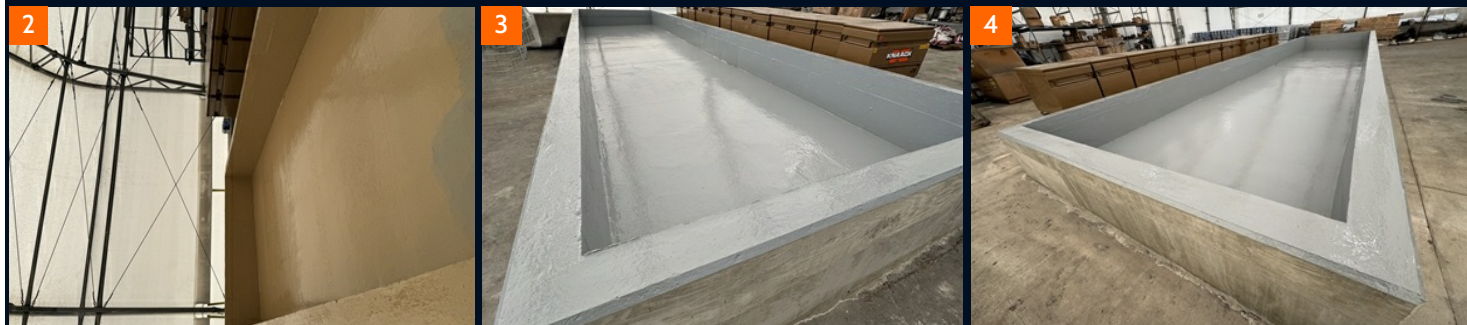
1. New Concrete Containment (Before)
2. Containment - 1st Coat with Belzona 5811 (Khaki)
3. Containment - Final/Second Coat with Belzona 5811 (Grey)
4. Containment - Complete

Since the concrete had not been coated, a high pressure (3000 psi+) pressure washer was used to clean and create a scarified surface. We proceeded to brush/roll apply 2 coats of Belzona 5811.
