# BELZONA 5811 IMMERSION GRADE SAVES CUSTOMER YEARS AND MILLIONS OF DOLLARS

ID: 9986

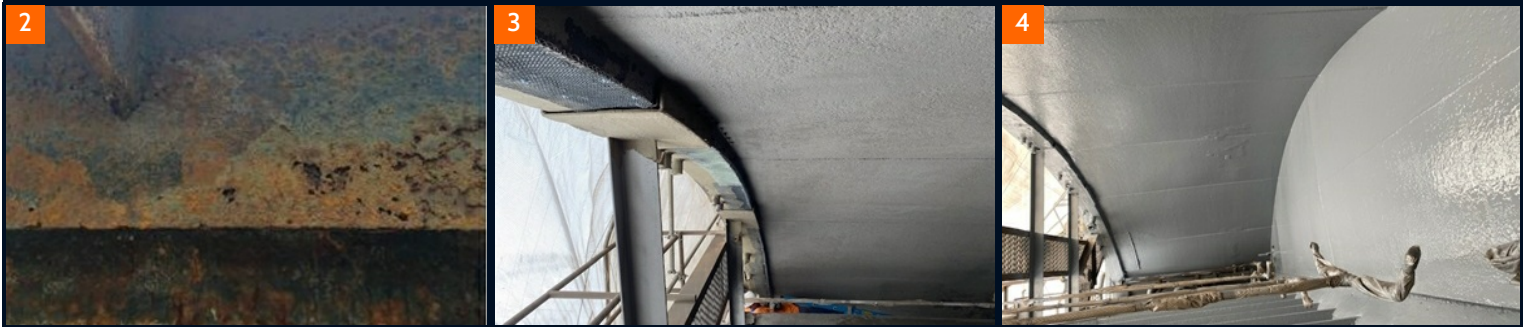
The Customer thought this clarifier tanks days were over. They submitted a permit for a new one and was told the permitting process would take five years so they started looking for a different solution. The previous coating they had installed came off in sheets and the corrosion under it had caused severe damage to the tank.

1. Previous coating was failing
2. An example of the damage corrosion caused here.
3. Steel was bonded to the top of the tank to provide more stability.
4. Section of the finished Belzona 5811 application.

Blast cleaned the steel which also removed the previous coating. Tack welded expanded metal where needed. Rebuilt corroded, pitted and expanded metal areas with Belzona 1111 (Super Metal). Spray applied two coats of Belzona 5811 (Immersion Grade).
