# MECHANICAL ROOM FLOORING

ID: 9989

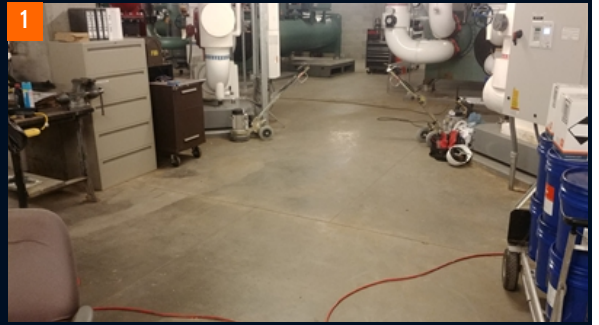
This mechanical room was not water tight. The customer was worried about the room flooding and getting into the server and electrical rooms attached. As well as flooding out underneath the doors into the hallway.

1. Standard concrete floor
2. During surface prep
3. After berms and coating
4. After berms and coating
